DEPARTMENT OF TRANSPORTATION

Contract #: 04-0120F4Cty: SF/ALA Rte: 80 PM: 13.2/13.9File #: 1.28**WELDING INSPECTION REPORT****Resident Engineer:** Casey, William**Address:** 333 Burma Road**City:** Oakland, CA 94607**Report No:** WIR-028001**Date Inspected:** 18-Jul-2012**Project Name:** SAS Superstructure**OSM Arrival Time:** 700**Prime Contractor:** American Bridge/Fluor Enterprises, a JV**OSM Departure Time:** 1900**Contractor:** American Bridge/Fluor Enterprises, a JV**Location:** Job site**CWI Name:** Jesse Cayabyab**CWI Present:** Yes No**Inspected CWI report:** Yes No N/A**Rod Oven in Use:** Yes No N/A**Electrode to specification:** Yes No N/A**Weld Procedures Followed:** Yes No N/A**Qualified Welders:** Yes No N/A**Verified Joint Fit-up:** Yes No N/A**Approved Drawings:** Yes No N/A**Approved WPS:** Yes No N/A**Delayed / Cancelled:** Yes No N/A**Bridge No:** 34-0006**Component:** Tower**Summary of Items Observed:**

Electroslag Weld Excavations

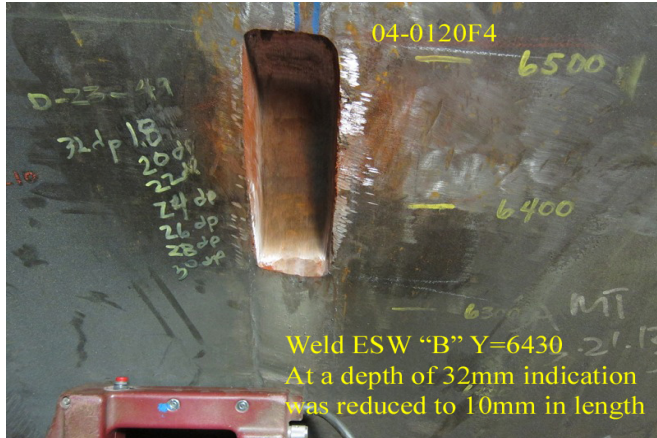
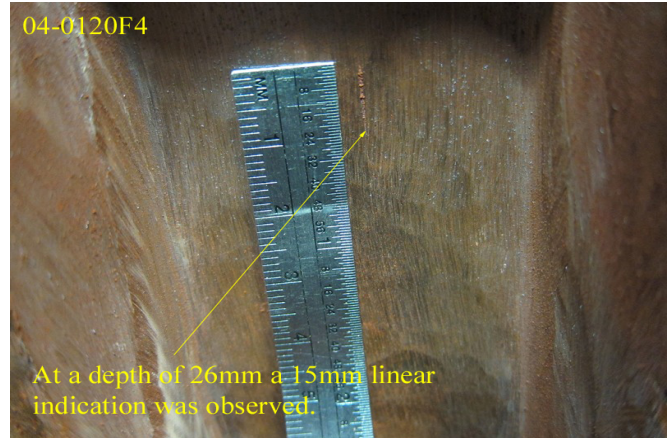
ESW "B" Face A from Y=6330~6530 for a longitudinal recordable indication ultrasonically detected at approximately Y=6430 (+8 AWS db rating.)

Initial excavation 18mm in depth- No indications observed. At a depth of 26mm a 15mm linear indication was

observed. The depth of the excavation at the end of the QAI's shift was measured to be 32mm with one (1) remaining 15mm linear indication. Further grinding of the indication will be required on a later shift.
